STUDY OF FLOOD CAUSES IN PESAREAN VILLAGE, ADIWERNA DISTRICT, TEGAL REGENCY

ABSTRACT

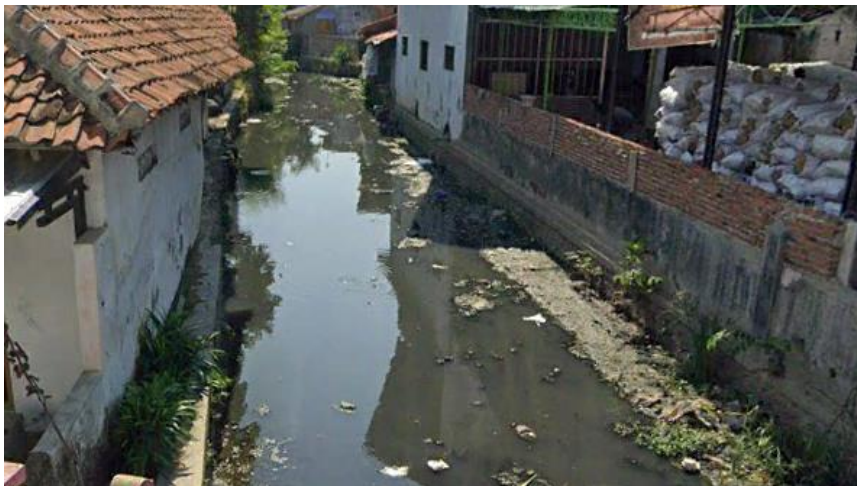
The condition of the Jembangan River in Pesarean Village is experiencing siltation due to sedimentation, so that only 2-3 meters of depth remain, This is caused by sedimentation of sludge, aquatic plants and domestic waste, causing the Jembangan River to have excess capacity when it rains. The overflow of water caused flooding and inundated parts of the Pesarean village.

Figure 2. Sedimentation on Jembangan River
Source : google earth street view

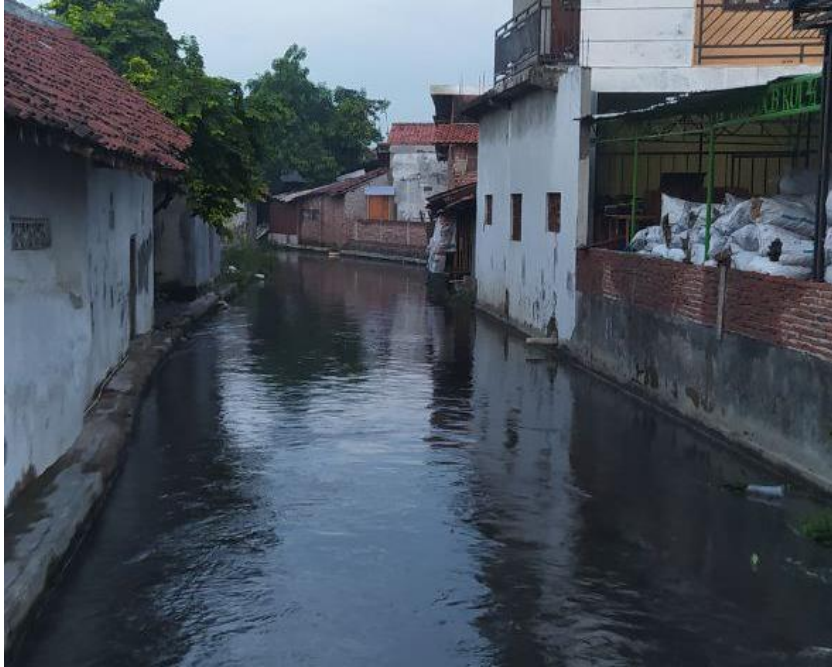
Figure 3. Jembangan River's Flood
Source : Primary data
